**CASE STUDY 1**

A 5MW anaerobic digestion site based in Northern England, utilising predominantly food waste.

# Started February 2019 – December 2020

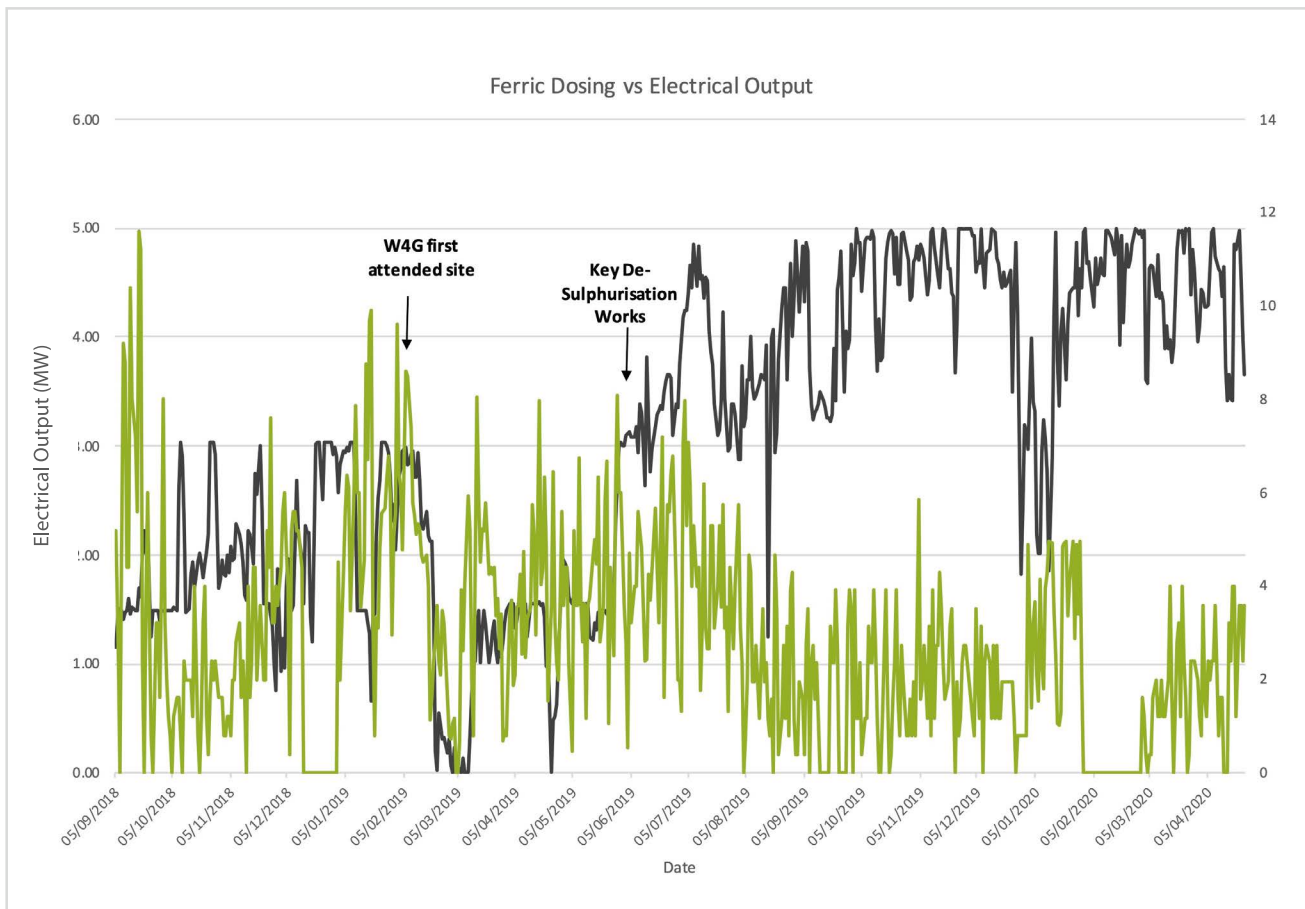
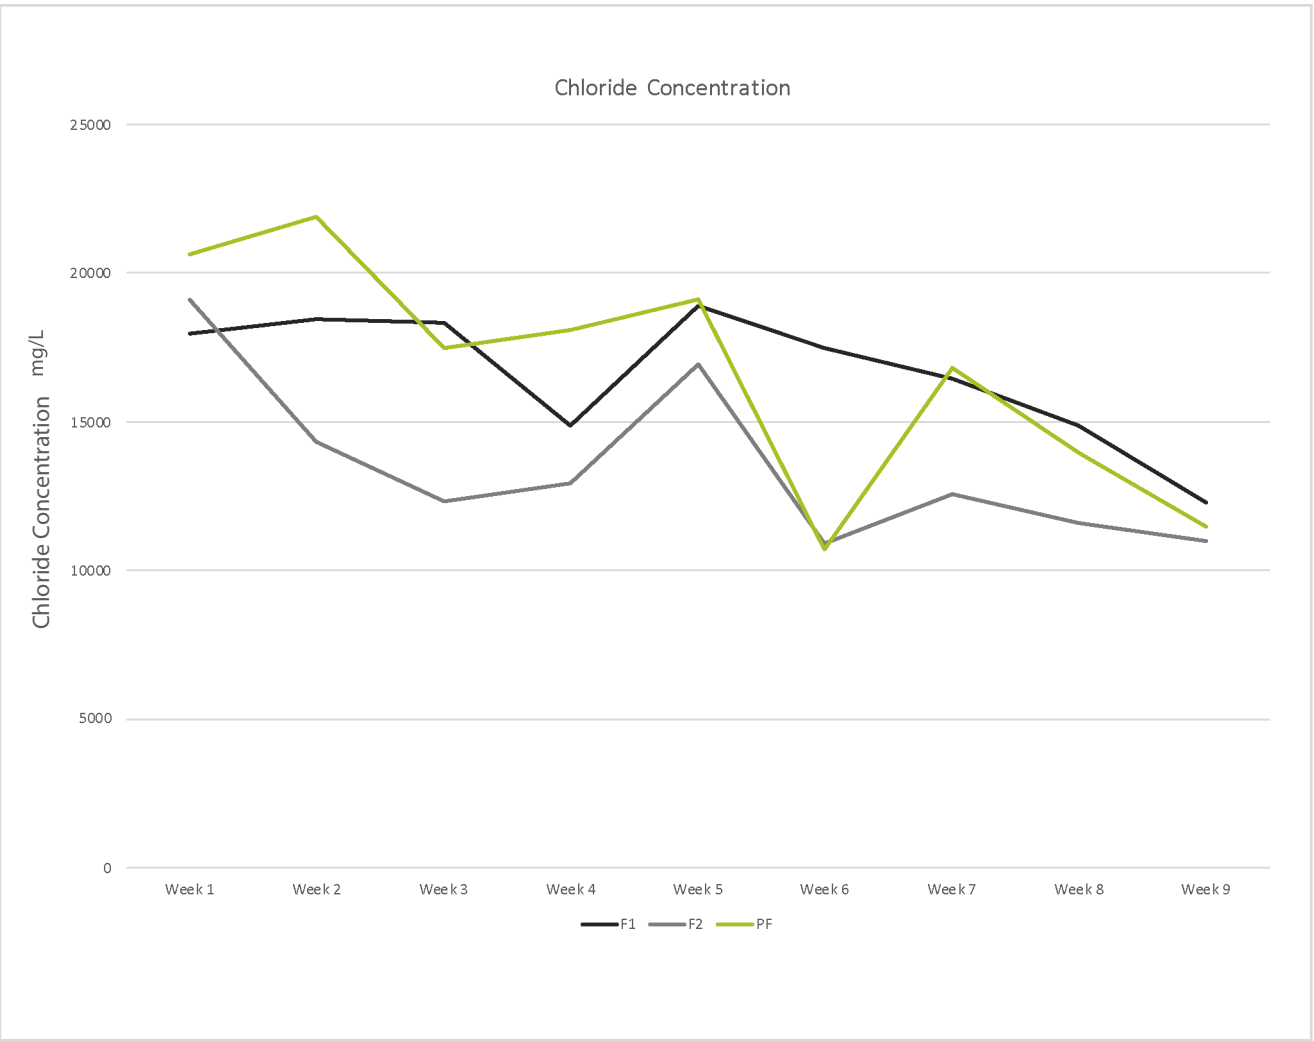
Due to the excessive ferric chloride usage for H<sub>2</sub>S control, the chloride concentration within the digesters was extremely high.

Individual feedstocks were analysed for chloride, and many were found to contain to have high chloride concentrations, many containing excess cleaning chemicals, which were both undesirable and not monitored going on to the plant.

As well as reducing the ferric chloride dosing, we adapted the feedstock recipe to remove harmful waste streams, and produce healthier digesters for the bacteria.

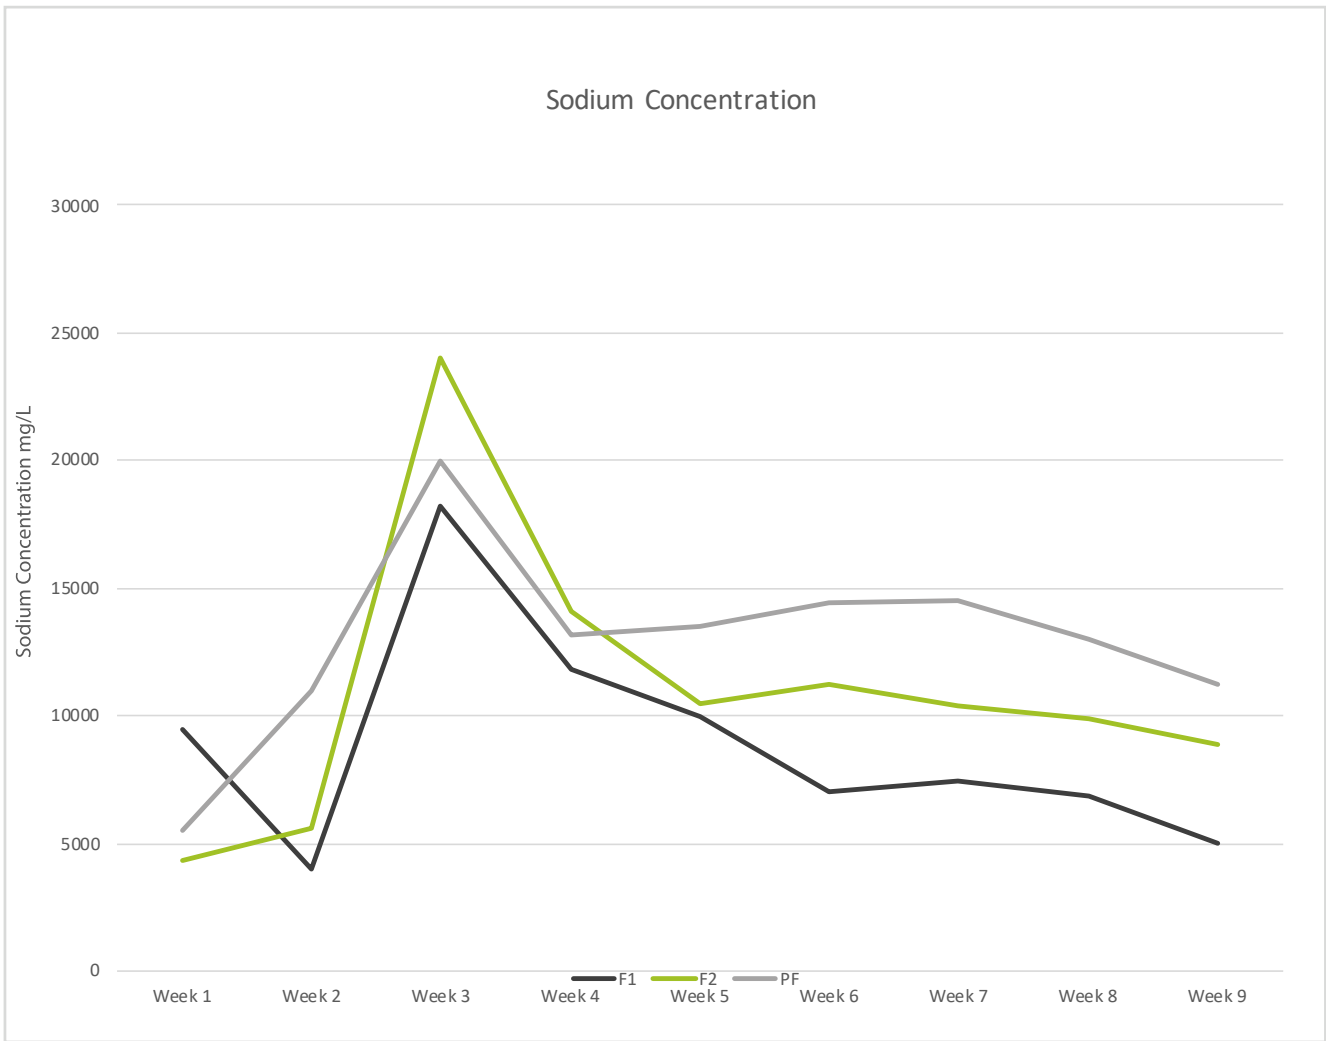
Initially, the sodium concentrations were not excessively high within the digesters. However, within days of us beginning to look into these digesters, the client was offered a high volume of ‘good quality feedstock’ which needed to be moved quickly.

The client took in a large quantity of waste containing an extremely high concentration of sodium, which was sufficient to raise the concentration of the digesters in the space of a few days. Our next time on site, we identified both the increase within the digesters and also identified the cause, and put the relevant control measures in place to bring the digesters back in line.

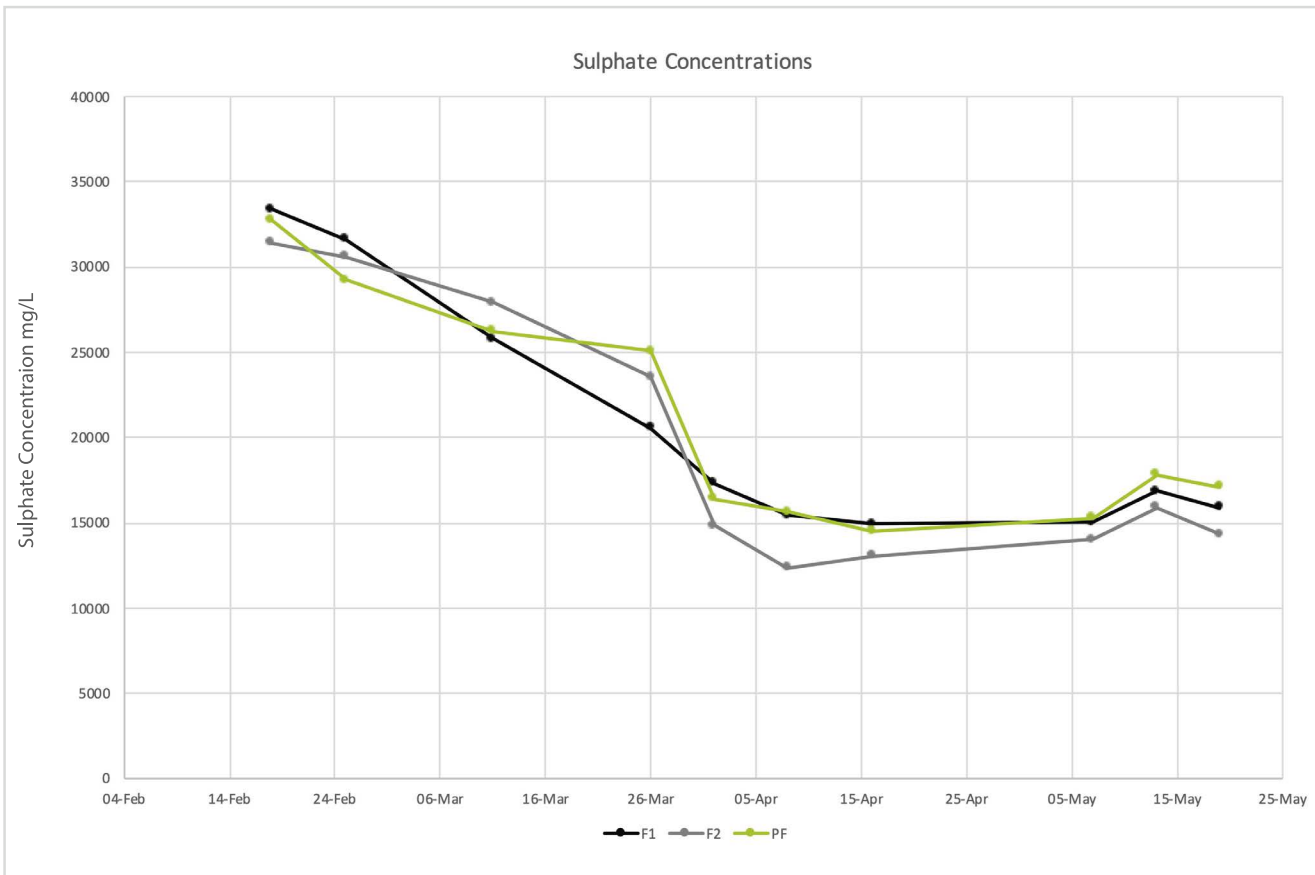
Over the course of 3 months we substantially reduced the sulphate concentrations within the digester.

Less sulphate within the digester means less sulphate available to be converted to H<sub>2</sub>S within the digesters.

A significant overhaul and assessment of each feedstock (and their individual benefits), lead to us re-vamping the feedstock recipe to a better suited combination.

Manage conditions within the digesters away from the optimum conditions (for the sulphate reducing bacteria as opposed to the other anaerobic bacteria present) to minimise the conversion of sulphate loading to below 10% (where it had been in excess of 20%) as well as managing the sulphate loading itself.

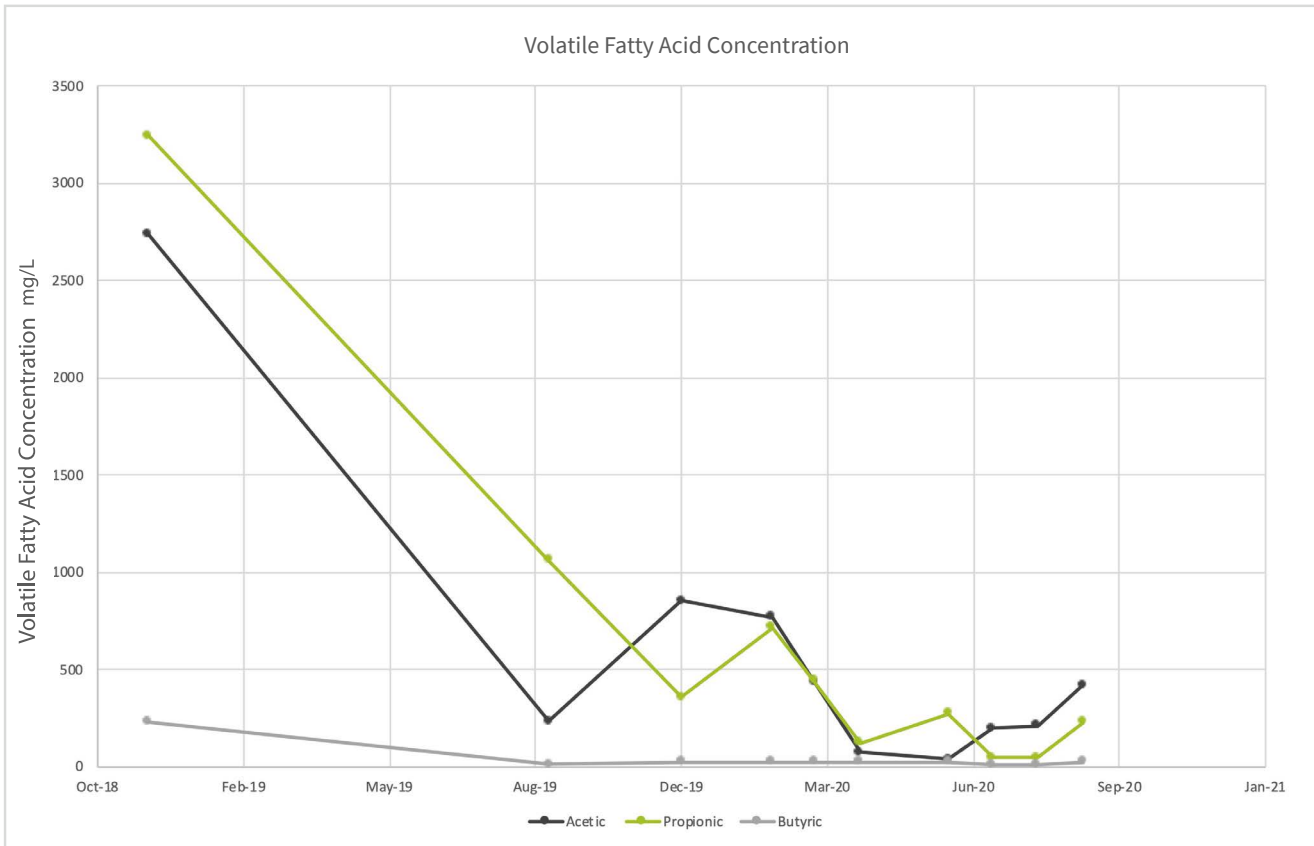
Every AD digester has a different acid profile, and understanding them is key to improving the plant's production.

At this site, there was a build-up of both acetic acid and propionic acids, indicating inhibition was preventing them from being converted to biogas.

Propionic acid itself is inhibitory at high concentrations within anaerobic digesters, so it is vital to reduce these levels to improve the digester's health.
