**CASE STUDY 3**

A site based on the west coast of Ireland, and utilising biogas to biomethane conversion. The site required a great deal of retro-fitting of equipment after the original suppliers closed.

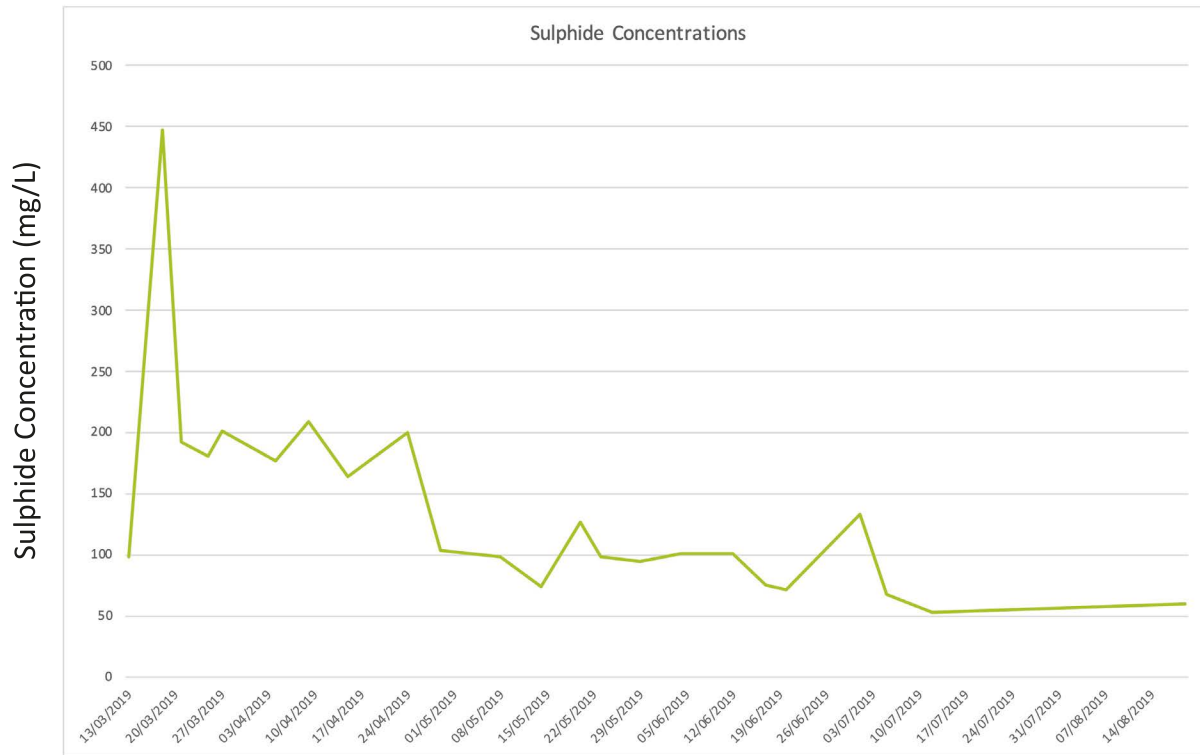
Key inhibitors were identified in the preliminary sampling, as part of the initial visit:

High sulphide concentrations identified within the digesters, due to incoming feedstocks with high sulphate, poor mixing and also limited H<sub>2</sub>S control including the management of iron hydroxide dosing.

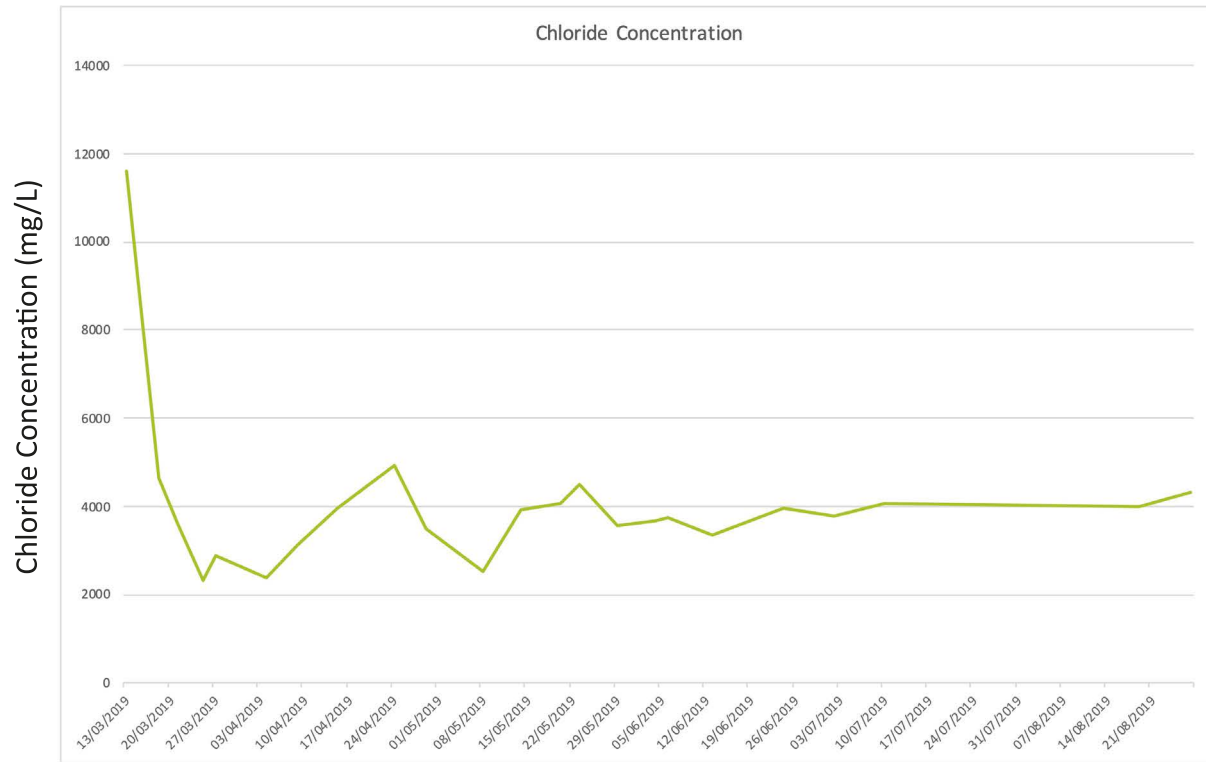
High chloride concentrations within digestate, which had accumulated, accumulated through settlement and mixing issues as well as high concentrations in incoming feedstocks.

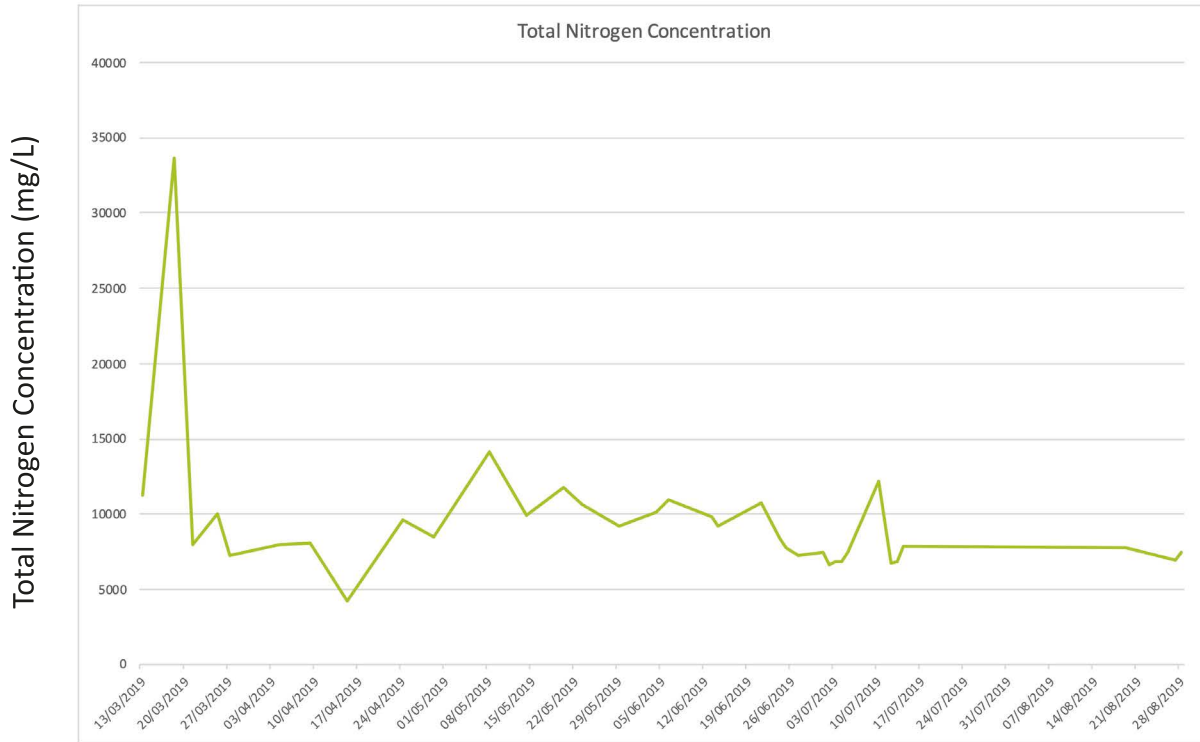
Combined ammonia found to be at excessively high levels, contributed to by the feedstock as well as recirculation. Immediate process changes implemented saw the levels drop, and W4G management saw levels hold at a reduced level.
